Cybox Jungle Gym Cable Crossover 17090 Incorrect Cable Routing

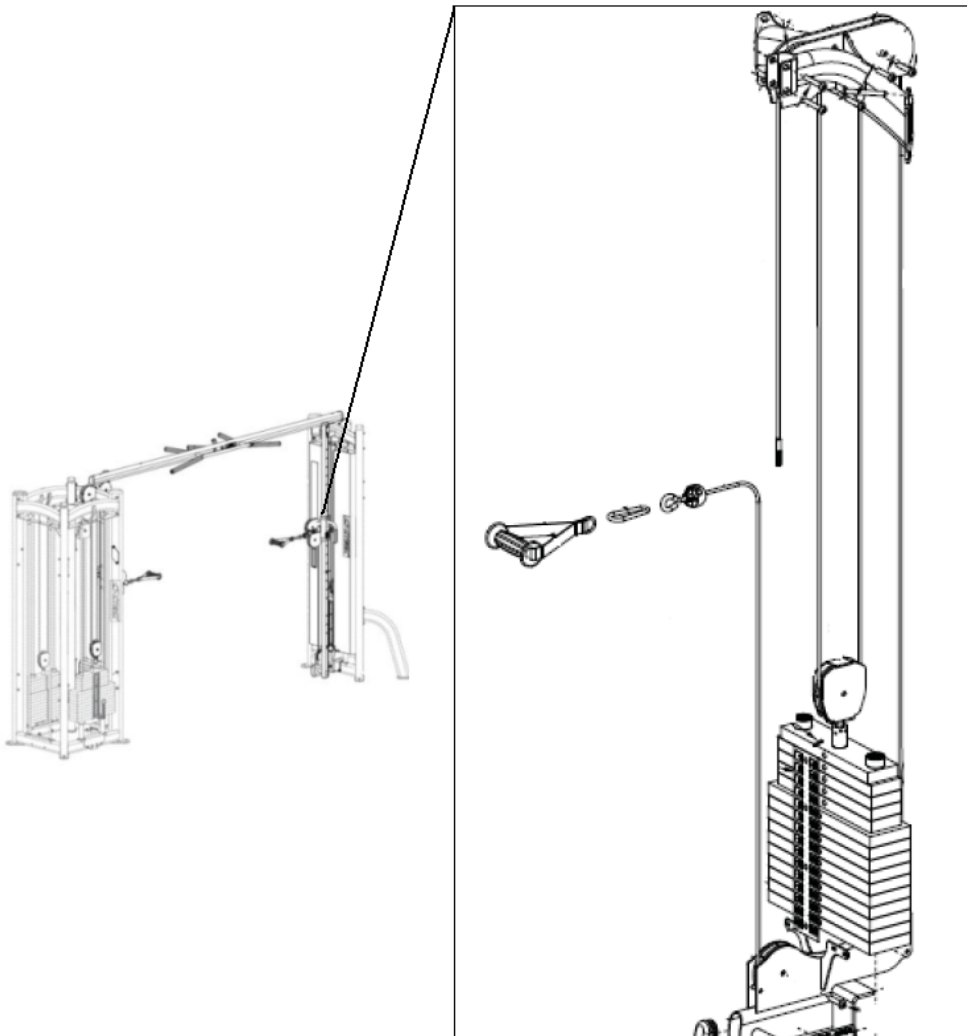
Cybox has received reports of incorrect cable routing during installation on the Jungle Gym Cable Crossover Stations, model 17090. Incorrect routing of the cable can result in serious injury and poor operation. Premature wear may result if the cable is not routed correctly. To avoid injury, poor operation, and/or excessive wear; verify cables are routed correctly per the diagram below and ensure no interference from other components exist. Model 17091 was released in December 2010 with provisions to prevent misrouting the cable.
